BLACK STURGEON LAKES PROPOSED SUBDIVISION FISH HABITAT ASSESSMENT

SEPTEMBER 2008

Submitted to assist in meeting the fisheries requirements of the application for subdivision placed forth by Bill Scurfield to the City of Kenora for lots 1, 7, and 9 on property located on Lower Black Sturgeon Lake.

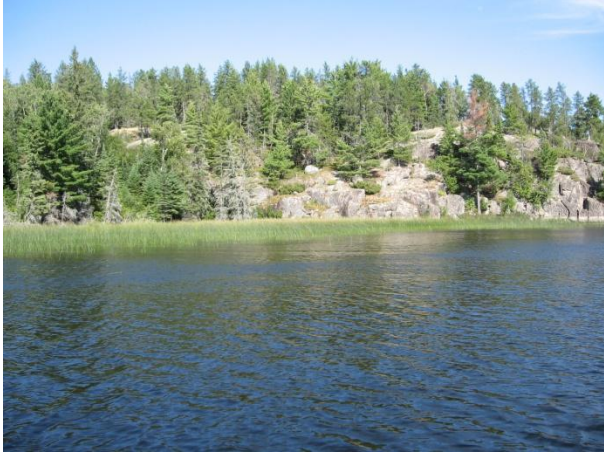
Figure 1 -View of Lot #1 from the water

Riparian – Open canopy with mature white pine, spruce and jack pine. Immature white birch, spruce and balsam fir also present. Understory has juniper bushes present.

Shoreline – Bedrock dominated with steep slope of 5 m to 20 m high cliffs along majority of lot.

Fish Habitat – The entire lot has a gradual drop off with depths of less than 1 m extending out for greater than 10 m from shore.

Lot # 1 was found to have high potential northern pike spawning habitat along the majority of the shoreline. The 20 m on the extreme southeast end of the lot was the exception, lacking sufficient aquatic vegetation to constitute high potential spawning habitat. Therefore, it is recommended that shoreline development be permitted only on the 10 m adjacent to the southeastern edge of lot #1 (Figure 13). The designated area is 10 m, and not 20 m, to account for boat movement and other activities along the northwestern side of any shoreline development. This 10 m buffer from identified critical habitat will help to ensure that any impacts of development on the habitat will be minimized. It is also recommended that best management practices for shoreline development are followed and that no dredging or aquatic plant removal take place along this lot to ensure that any impact upon the aquatic habitat is minimized.

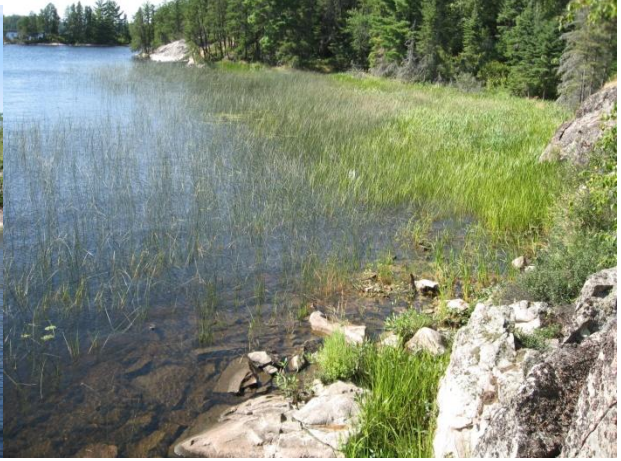
Figure 2 – View of Lot #1 from east boundary looking west

For the southeastern 20 m of the lot, the substrate for the initial 2 to 5 m from the water's edge is dominated by multiple layers of small to medium-sized rocks interspersed with large chunks of bedrock. The beyond the multiple layers of rock is a silt and sand bottom with aquatic vegetation dominated by rushes with small pockets of lily pads extending out to approximately 15 m from the shoreline (Figure 3).

Discussion - The 20 m along the southeastern edge of the proposed lot #1 is dominated by a moderate density of rushes on a sand and silt substrate. It is felt that this area would not have adequate submerged aquatic vegetation present during the early spring to constitute significant northern pike spawning habitat. The southeastern 20 m of lot #1 has low potential for northern pike spawning activity.

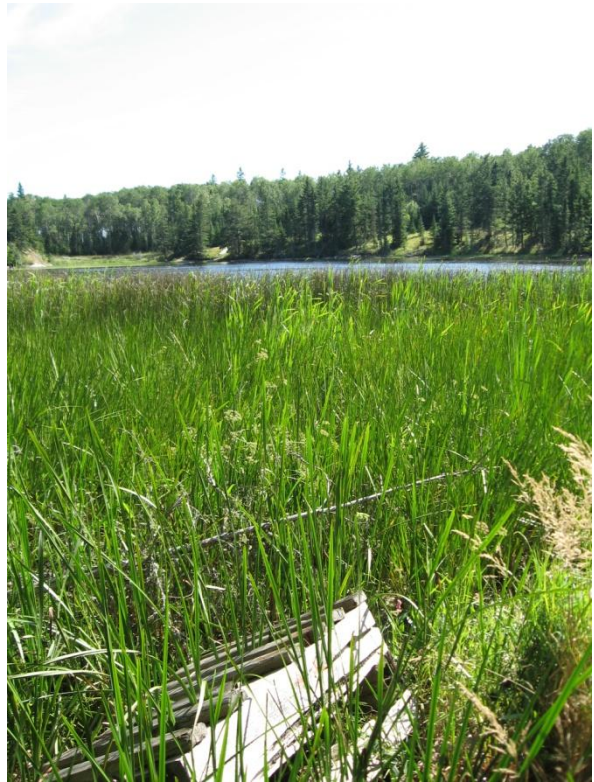
Figure 4 – Looking south from lot #1 west boundary

For the remaining northwestern portion of the proposed lot, the aquatic vegetation is progressively more dense and diverse proceeding to the lot 1/lot 2 boundary (Figure 4). Aquatic vegetation along this section comprises of bulrushes (cattails), floating pond weed, wild celery, and lily pads with the vegetation density the greatest adjacent to the shoreline. The emergent aquatic vegetation is present to approximately 20 to 30 m from the shore, beyond which broad-leaved submergent macrophytes dominate.

The remaining northwestern section of the lot has the diversity and density of aquatic vegetation present to provide for adequate spawning habitat for northern pike. Therefore, it is felt that the northwestern portion of proposed lot #1 has high potential for northern pike spawning activity. The multiple-layered rocks located along the eastern end of the lot have the physical characteristics of walleye, whitefish and white sucker spawning habitat. However, due to the lack of significant fetch, this area will not have adequate wave action to adequately oxygenate gestating eggs. Therefore, this section has low potential for walleye, white sucker and whitefish critical spawning habitat.

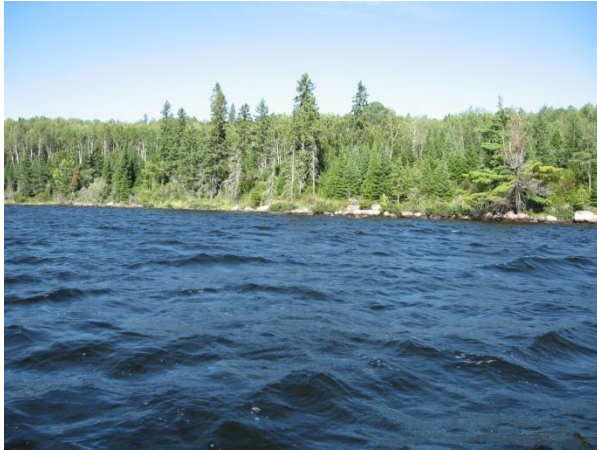
Figure 5 – View of Lot #7 from the water

Riparian – Moderate canopy cover with tree species dominated by mature spruce with some white birch. Juniper bushes present in the understory.

Shoreline – Gradual slope dominated by bedrock and large boulders.

Discussion – The southern 20 m of lot #7 has all of the physical characteristics of walleye, whitefish, and white sucker spawning habitat. The site has a significant fetch to the south and west to provide for adequate wind and wave action to oxygenate gestating eggs. Therefore, it is felt that the southern 20 m of lot #7 is high potential spawning habitat for walleye, white sucker and lake whitefish.

The remaining northern portion of lot #7 does not have the quality or quantity of suitable substrate to constitute significant spawning habitat. Therefore, lot #7 has low potential for spawning habitat. The presence of young-of-the-year and/or minnows along this section indicate that this section is rearing habitat for some fish species.

Lot #7 was found to have high potential walleye, whitefish and white sucker spawning habitat along the southern 20 m of the lot. Therefore, it is recommended that there be no shoreline development along the southern 20 m of lot #7. The remainder of lot #7 was found to be absent of any significant spawning habitat. There were young-of-the-year fish and/or minnows present in the aquatic vegetation along this northern portion of lot #7. However, these small fish will not likely be adversely impacted by shoreline development, and may actually benefit from the additional cover provided by structures along the shore. Therefore, it is felt that shoreline development may occur along the northern portion of lot #7 (Figure 14) without adversely impacting upon critical fish habitat. It is recommended that best management practices for shoreline development are followed and that no aquatic plant removal take place along this lot to ensure that any impacts upon the aquatic habitat is minimized.

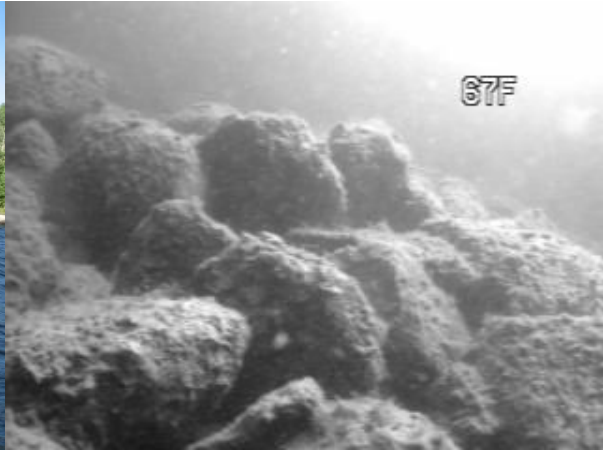
Figure 6 – Substrate along southern end of Lot #7

Fish Habitat – The 20 m at the southern edge of the lot is dominated by slab bedrock adjacent to the shore, with sections of multiple layers of small to medium-sized rocks (Figure 6).

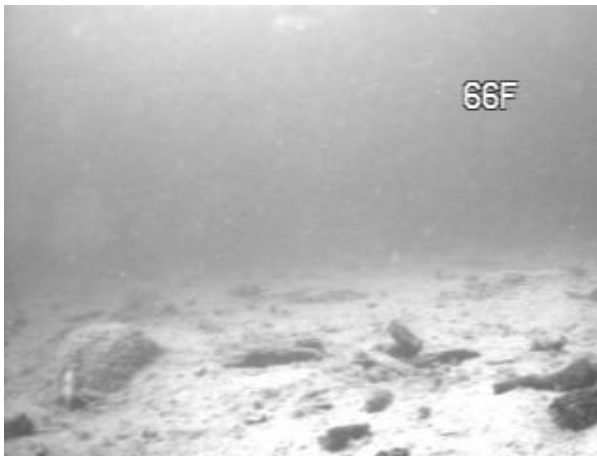
Figure 7 – Sand/silt substrate northern end of Lot #7

The remaining 30 m on the northern portion of the lot is dominated by a sand/silt substrate (Figure 7) with sections of submergent macrophytes (Figure 8), sections of scattered medium-sized rocks, and sections of a single layer of small to medium-sized rocks. Young-of-the-year fish and minnows were present in abundance in the macrophytes along this section.

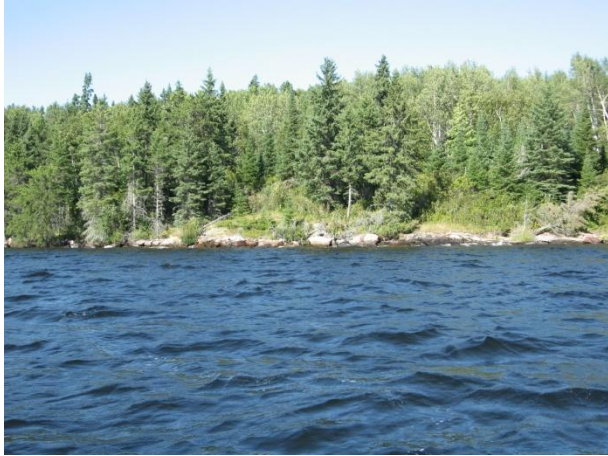
Figure 9 – View of lot #9 from the water

Riparian – Moderate canopy cover with mature balsam fir, spruce and white birch. The understory is dominated by deciduous shrubs and juniper bushes.

Shoreline – Dominated by large boulders with sections of bedrock. Proposed lot has a moderate to gradual profile.

Discussion – The southeastern 15 m is dominated by bedrock and a single layer of rock on a sand/silt base. Both of these substrate types lack sufficient cracks and crevices to constitute significant spawning habitat for walleye, lake whitefish, and white sucker. Therefore, this section has low potential for critical fish spawning habitat.

The remaining northwestern portion of lot #9 has multiple layers of small to medium-sized rocks present throughout. This substrate has the physical characteristics of walleye, lake whitefish, and white sucker spawning habitat. The southwestern facing profile of lot #9, in addition to the significant fetch to the south and west, indicate that this section will have sufficient wind and wave action to oxygenate gestating eggs. Therefore, it is felt that this northwestern portion of lot #9 has high potential for critical spawning habitat for walleye, lake whitefish, and white sucker.

Lot #9 was found to have high potential walleye, whitefish, and white sucker spawning habitat along the majority of the shoreline. The exception was the 15 m on the extreme southeastern end of the lot, which lacked the appropriate substrate for high potential spawning habitat. Therefore, it is recommended, with the exception of the extreme southeastern 15 m, that there be no shoreline development along lot #9. Development along this area must take place in a manner so as to not interfere with the ability of wind and waves to act upon the identified spawning habitat to the northwest. It is felt that shoreline development may occur on the southeastern end of lot #9 (Figure 15) without adversely impacting upon identified potential critical fish habitat providing it meets the following requirements:

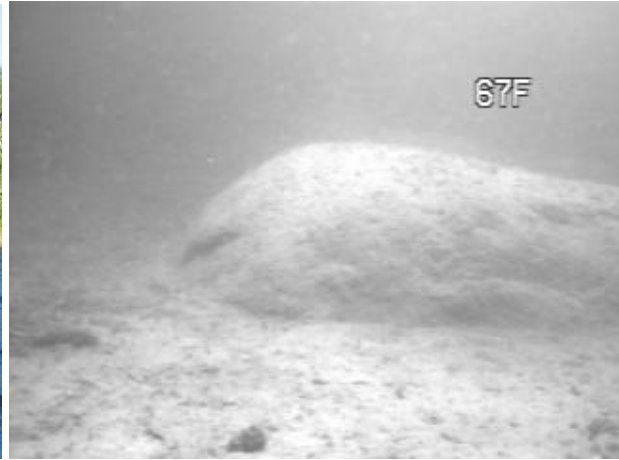
Figure 10 – Southeast end of lot #9

Fish Habitat – The 5 m on the southeastern end of lot 9 adjacent to the lot 8/9 boundary is dominated by a single layer of scattered small to large rocks on a sand/silt base with scattered submergent macrophytes (Figure 10). For the 5 to 15 m to the northwest of the lot 8/9 boundary, the substrate is dominated by a bedrock point surrounded by a single layer of interspersed rock on a sand/silt base. The remainder of lot #9 is dominated by sections of multiple layers of small to medium-sized rocks (Figure 11) interspersed with large boulders, sections of medium to large rock (Figure 12), and small sections of a single layer of small to medium-sized rock on a sand base. Despite the mixing of these substrate types, the multiple layers of small to medium-sized rocks pervades throughout the northwestern portion of the lot.
