## Addendum #1

Date: September 8, 2026  
 Owner: City of Kenora  
 Title: Request for Proposals – Purchase and Rehabilitation of the Kenricia Hotel

# Schedule A

### Fire Alarm System Test and Inspection Report (Ref CAN/ULC-S536-04)

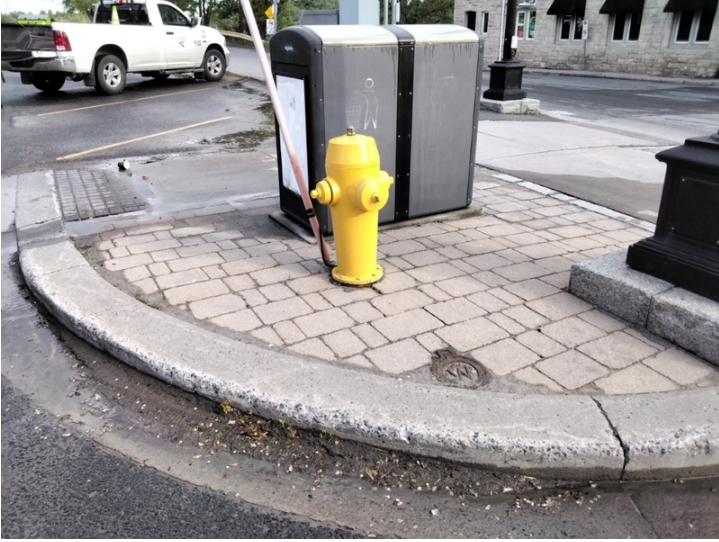
| <b>Photo of Hydrant Inspected</b><br> | <b>Customer: Kenora 1075</b> | | |

| <b>Pass: ✓</b> | | <b>Failed:</b> | |

| Fire Hydrant Details | | | | |
|---|--|---|---|---|
| Condition of isolation valve casing: | | N/A: | Good: ✓ | Fair: |
| Thread condition: | | Good: ✓ | | Fair: |
| Cap condition: | | Good: ✓ | | Fair: |
| Paint condition: | | Good: ✓ | | Fair: |
| Barrel condition: | | Good: ✓ | | Fair: |
| Gasket condition: | | Good: ✓ | | Fair: |

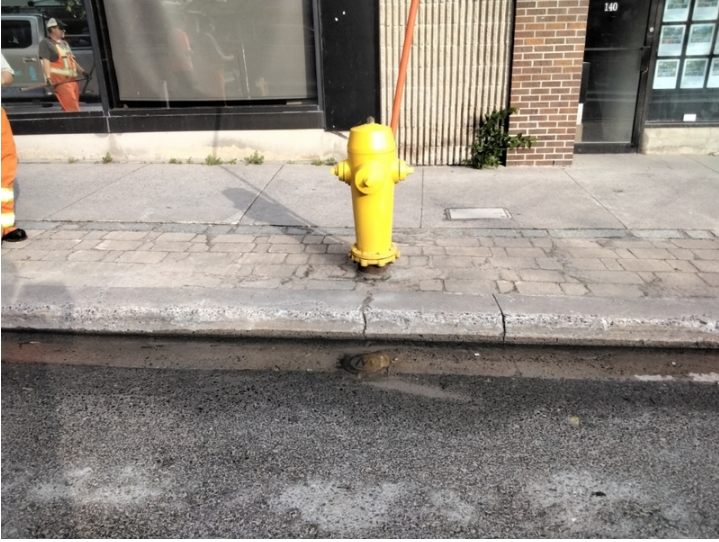
| <b>Photo of Hydrant Inspected</b><br> | <b>Customer: Kenora 1076</b> | |

| <b>Pass: ✓</b> | | <b>Failed:</b> |

| Fire Hydrant Details | | | | |
|---|--|---|---|---|
| Condition of isolation valve casing: | | N/A: | Good: ✓ | Fair: |
| Thread condition: | | Good: ✓ | | Fair: |
| Cap condition: | | Good: ✓ | | Fair: |
| Paint condition: | | Good: ✓ | | Fair: |
| Barrel condition: | | Good: ✓ | | Fair: |
| Gasket condition: | | Good: ✓ | | Fair: |

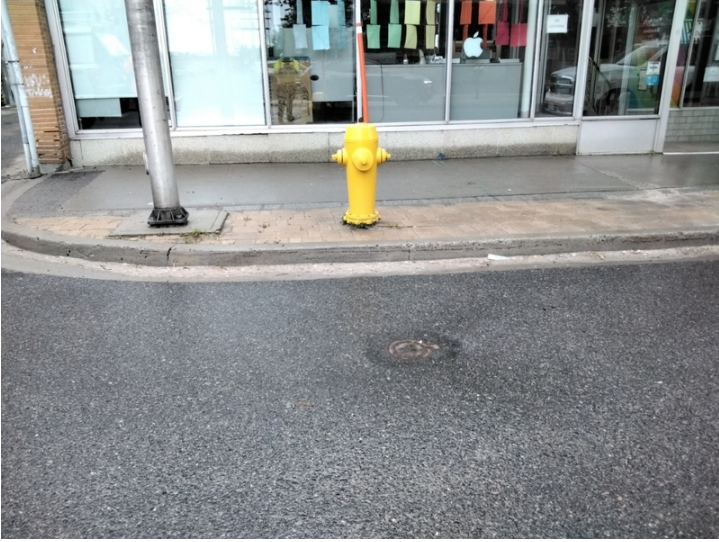
| <b>Photo of Hydrant Inspected</b><br> | <b>Customer: Kenora 1080</b> | |

| <b>Pass: ✓</b> | | <b>Failed:</b> |

| Fire Hydrant Details | | | | |
|---|--|---|---|---|
| Condition of isolation valve casing: | | N/A: | Good: ✓ | Fair: |
| Thread condition: | | Good: ✓ | | Fair: |
| Cap condition: | | Good: ✓ | | Fair: |
| Paint condition: | | Good: ✓ | | Fair: |
| Barrel condition: | | Good: ✓ | | Fair: |
| Gasket condition: | | Good: ✓ | | Fair: |
